Service Bulletin

Bulletin No.: 17-NA-384

Subject: Squeak, Rattle or Creak Noise Coming from Second Row/Rear Seat Area

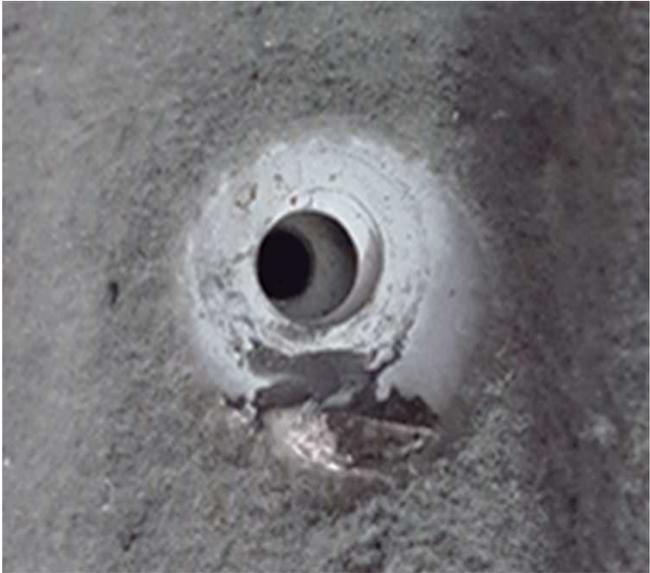
Involved Region or Country	North America, Europe, Russia, Middle East, Israel, Japan, Cadillac Korea (South Korea), Egypt, Australia/New Zealand
Condition	Some customers may comment on hearing a squeak, rattle or creak noise coming from the second row/rear seat area. The right 40% seat is more prone to this condition, however the left 60% seat could be affected.
Cause	<p>The condition may be caused by either of the following:</p> <div style="text-align: center;">

</div> <p style="text-align: right; font-size: small;">4911773</p> <p>Note: The "winking" is caused by excessive overlap of body panels and, as shown in the graphic above, the sheet metal holes are offset. This is most commonly found at the right rear fastener location of the right rear seat, or the left rear fastener of the left rear seat.</p> <ul style="list-style-type: none"> Possible "winking" condition of right rear 40% seat floor pan outboard track rear bolt hole, or the left rear 60% seat floor pan outboard track rear bolt hole. A seat track synchronization/torque condition that may require a torque sequencing of the seat attachment bolts, on either seat.

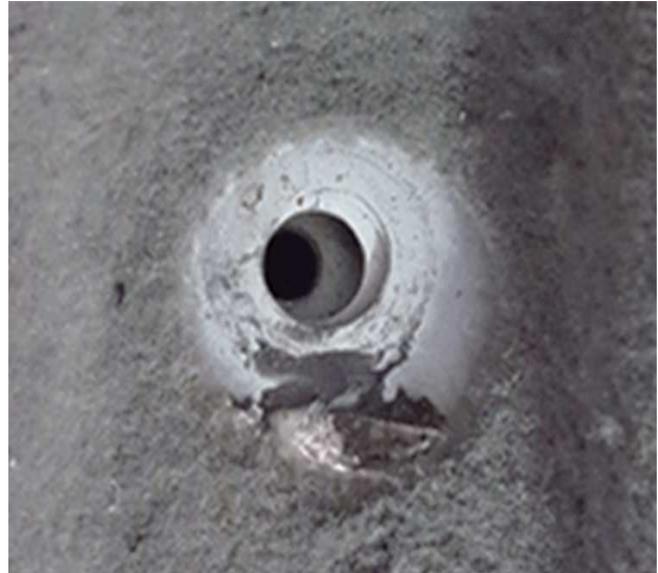
4911773

- 2.4. Ensure that both seat tracks are locked.
- 2.5. Loosen the outboard rear attachment bolt, then the inboard bolt.
3. inspect the right outboard rear seat fastener location of the right rear seat and/or the left outboard rear seat fastener location of the left rear seat for possible “winking” condition.

- If “winking” condition DOES exist, continue ahead to step #4 and remove sheet metal material.

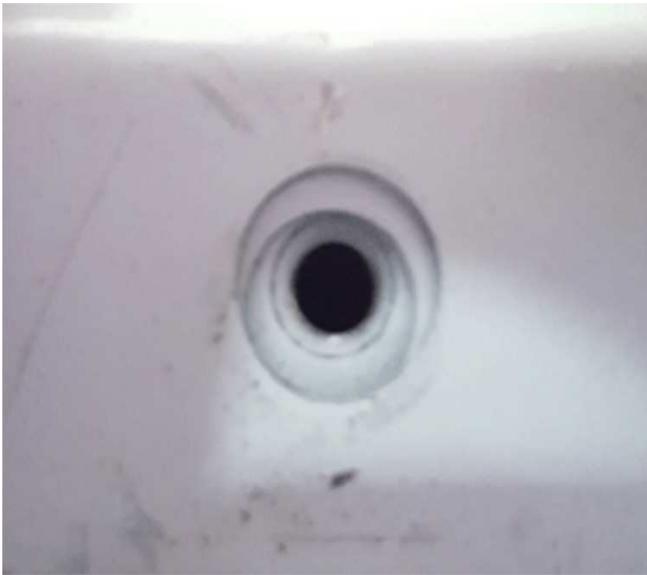
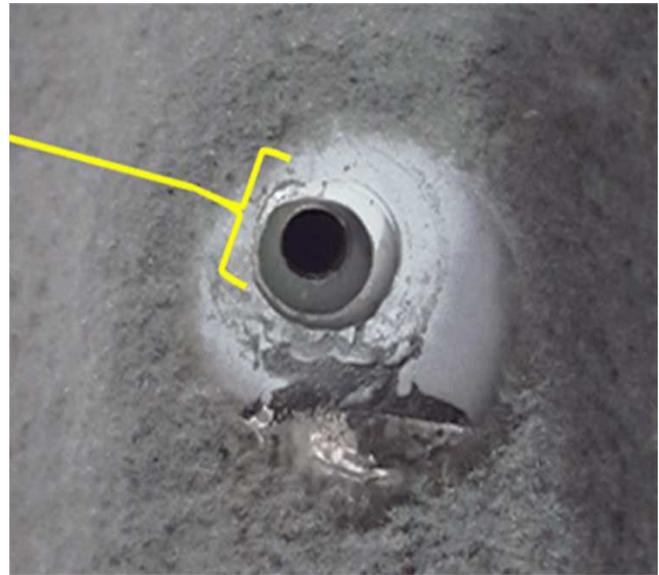
Note: In the graphic example above, the sheet metal is still offset, but the nut is centered enough to avoid contact of the seat bolt to the sheet metal.

4. Using a dremel, or suitable tool, grind a small amount of material from the floor sheet metal opening. Grind only enough of the overlapping metal to allow clearance for the seat bolt.
5. Use an air gun to blow out any metal debris in the nut and hole area.
